# Manhole Inspection Summary

Manhole # S21A1\_007MH

Insp Date: **6/18/08 8:31 AM**

**Location** Address: **2418 paca st**

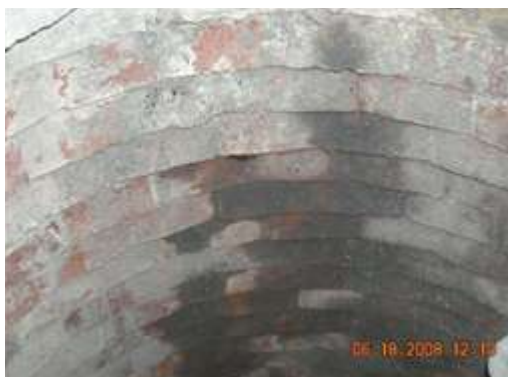
Defect 5

Infiltration: ☐ None ☐ Joint ☐ Cracks ☐ Mortar ☐ Roots ☒ **Wall**

infiltration @ corbel wall

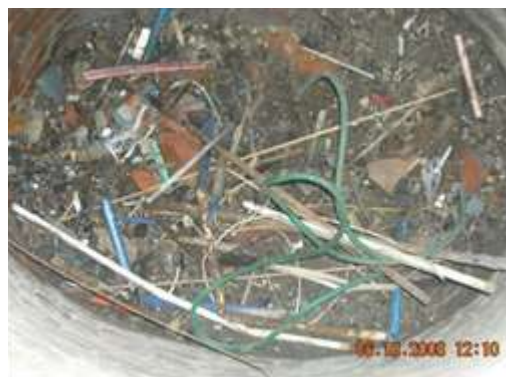
Defect 4

Condition: ☐ Sound ☐ Cracked ☐ Root Intrusion ☐ Deteriorated ☐ Leaks ☒ **Debris**

debris in terminal channel

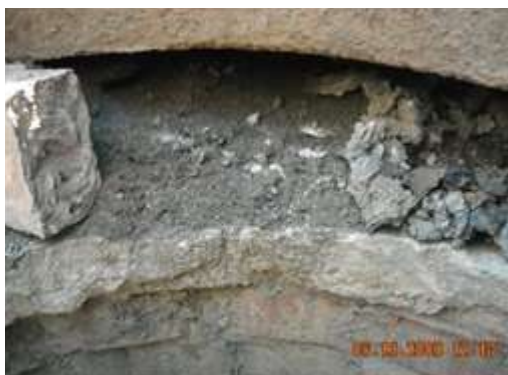
Defect 3

Condition: ☐ Sound ☐ Cracked ☐ Root Intrusion ☒ **Loose Brick** ☒ **Deteriorated**

deteriorated chimney

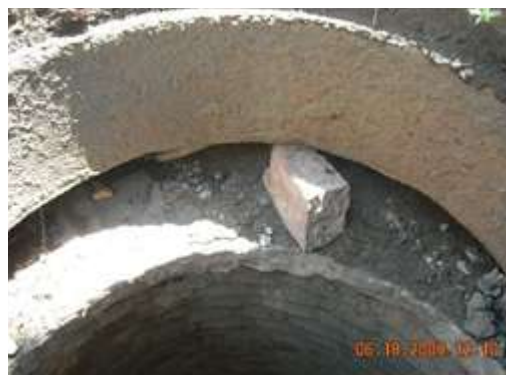
Defect 2

loose chimney brick

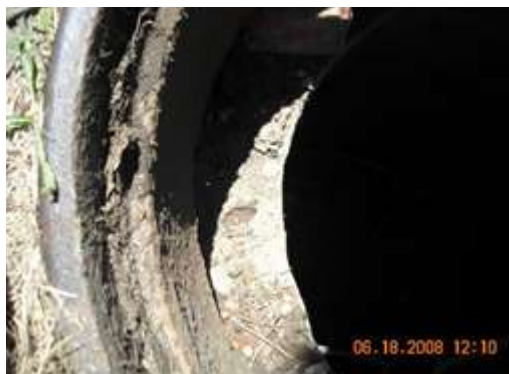
### Defect 1

Offset: **5** (in.)

frame offset

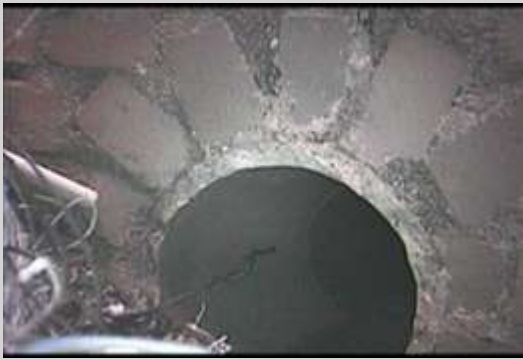
12 O'Clock Outflow

8 in. Circular Gravity Sewer  
Pipe Out @ 12 O'Clock

Deposits: ☐ None ☐ Mud ☐ Sludge ☒ **Debris** ☐ Grease

Silt Depth: **1** (in.) Deposits Extent: **Light**
